Modified Mercalli Intensity Scale

MMI Value	Description of Shaking Severity	Summary Damage Description Used on 1995 Maps	Full Description

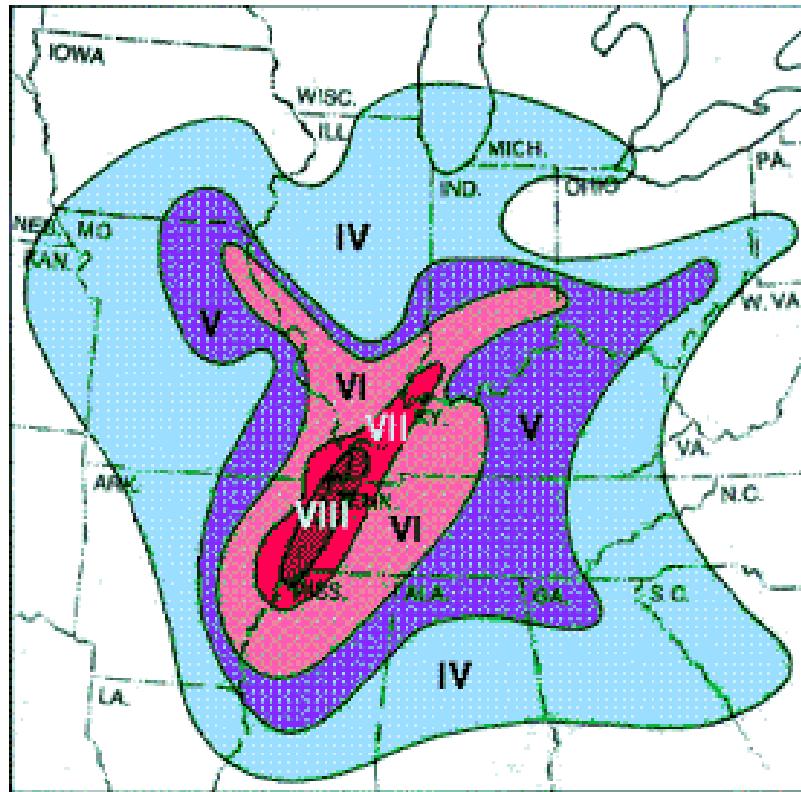
Map showing intensity for the New Madrid earthquake. (Image courtesy of the Central U.S. Earthquake Consortium) <http://earthquake.usgs.gov/learn/glossary/?termID=99&alpha=I>

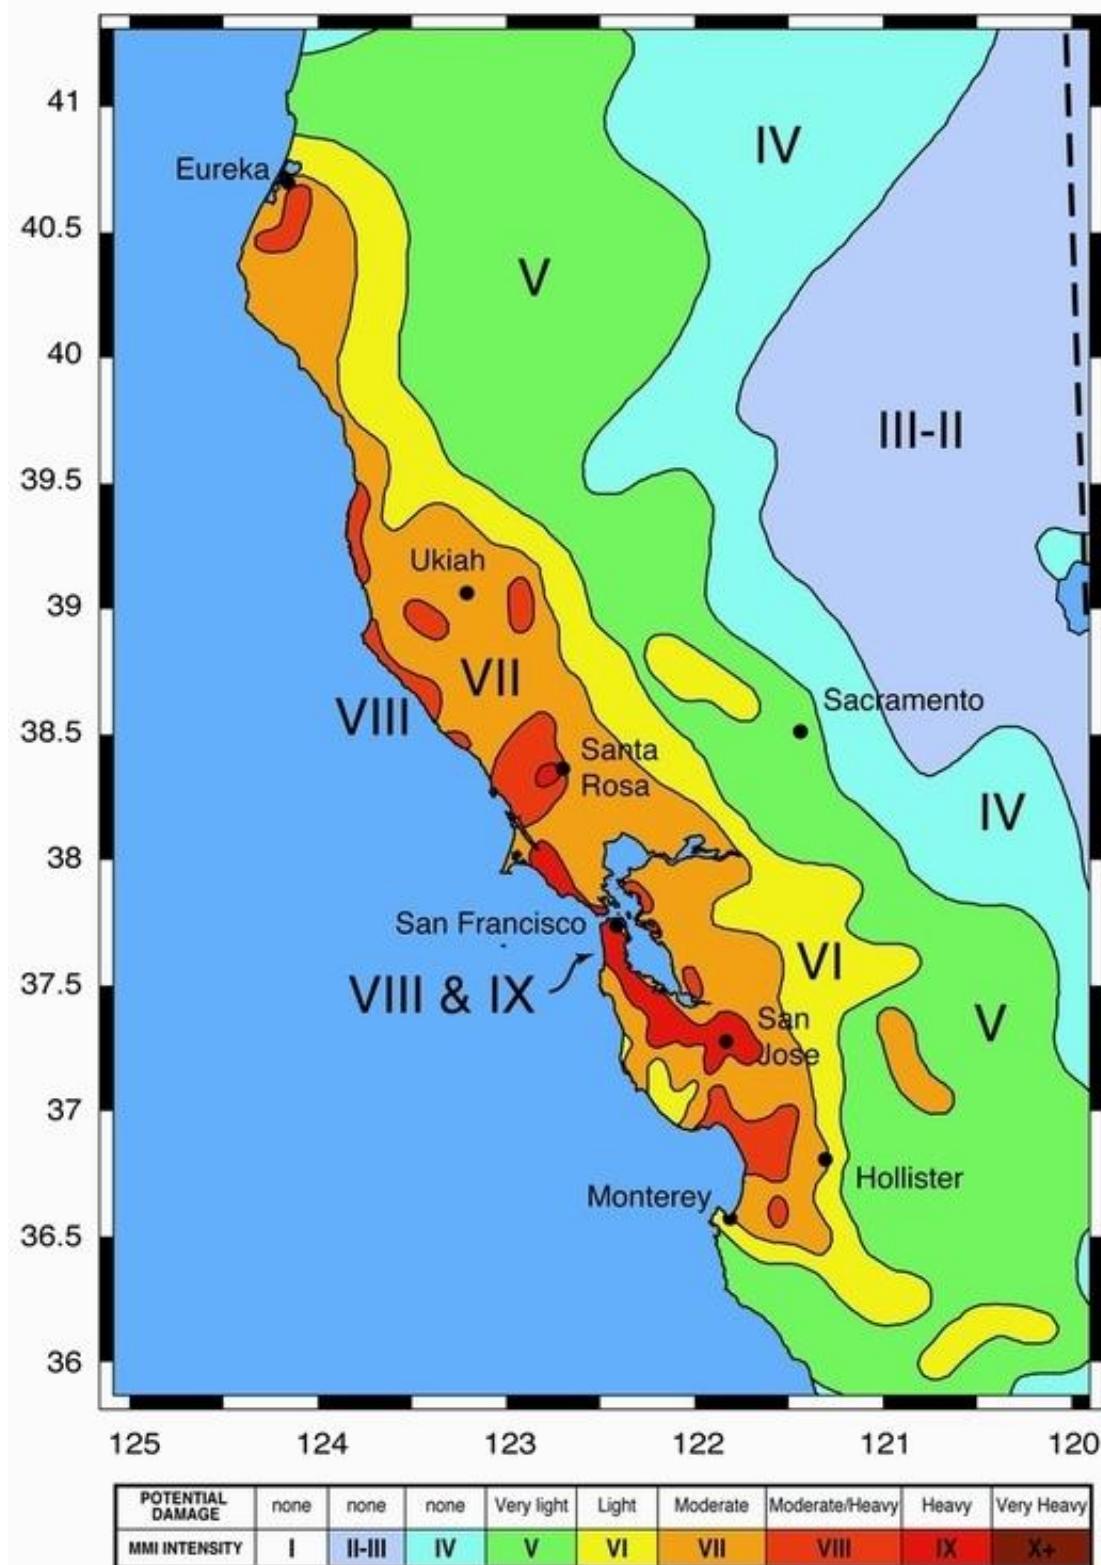
San Francisco 1906 Earthquake <http://pubs.usgs.gov/of/2005/1135/IntensityMaps.html>

MMI Contour Map for the 1906 earthquake from Stover and Coffman (1993)
